INFORMATION REPORT

SUBJECT Neubrandenburg Airfield (training for truck companies; Billings)

Neubrandenburg Airfield

Status: September 1957

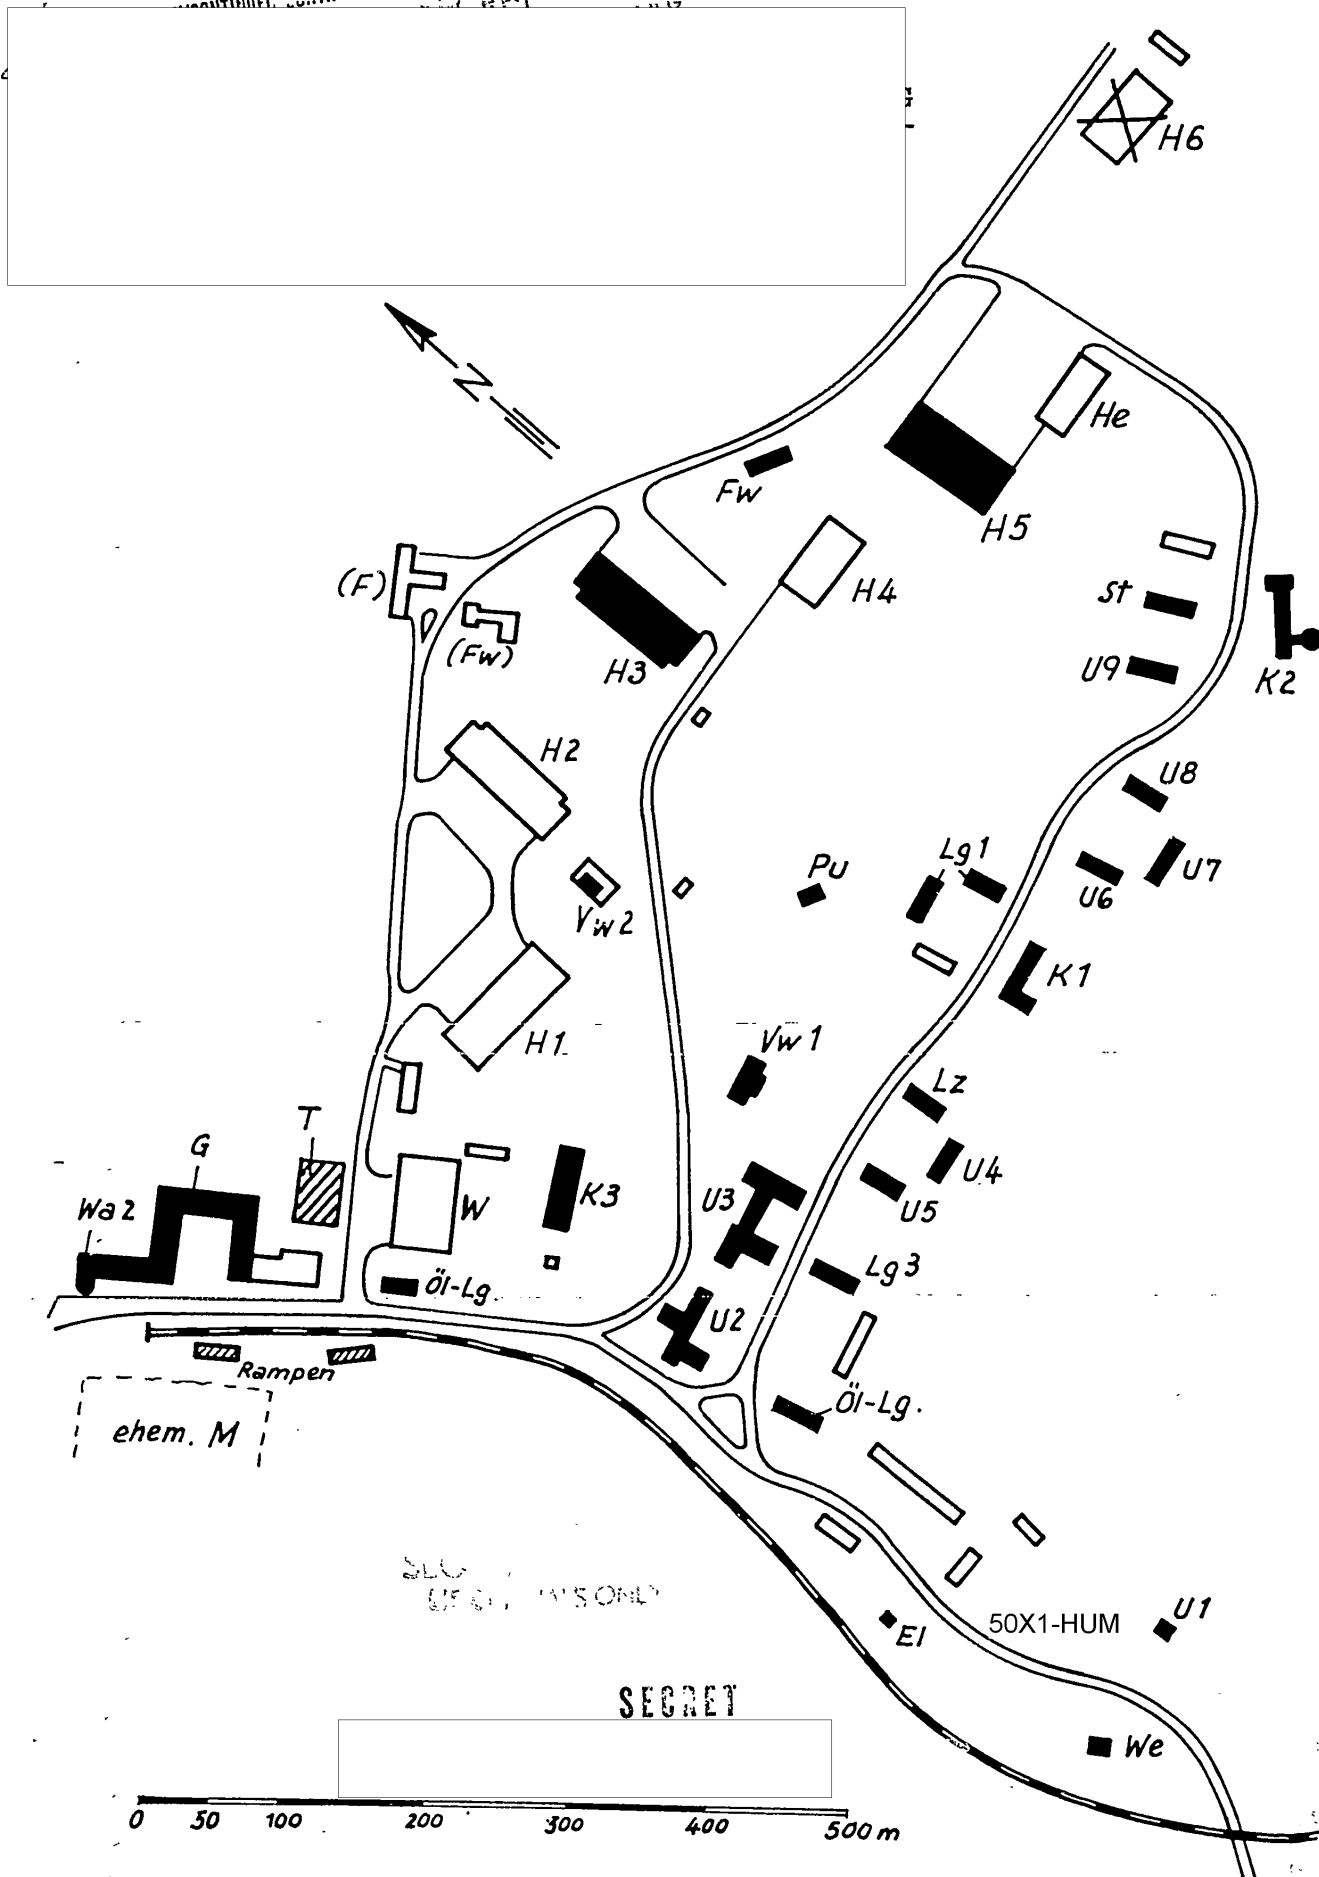
Annex

Attachment A: A map of Neubrandenburg airfield showing the locations of installations. 50X1-HUM
Attachment B: An enlarged section of Attachment A.

1. Comment. This information confirms the transfer of the instruction and training battalion from Bautzen. 50X1-HUM
2. Comment. For location and kind of the buildings, see Annex.

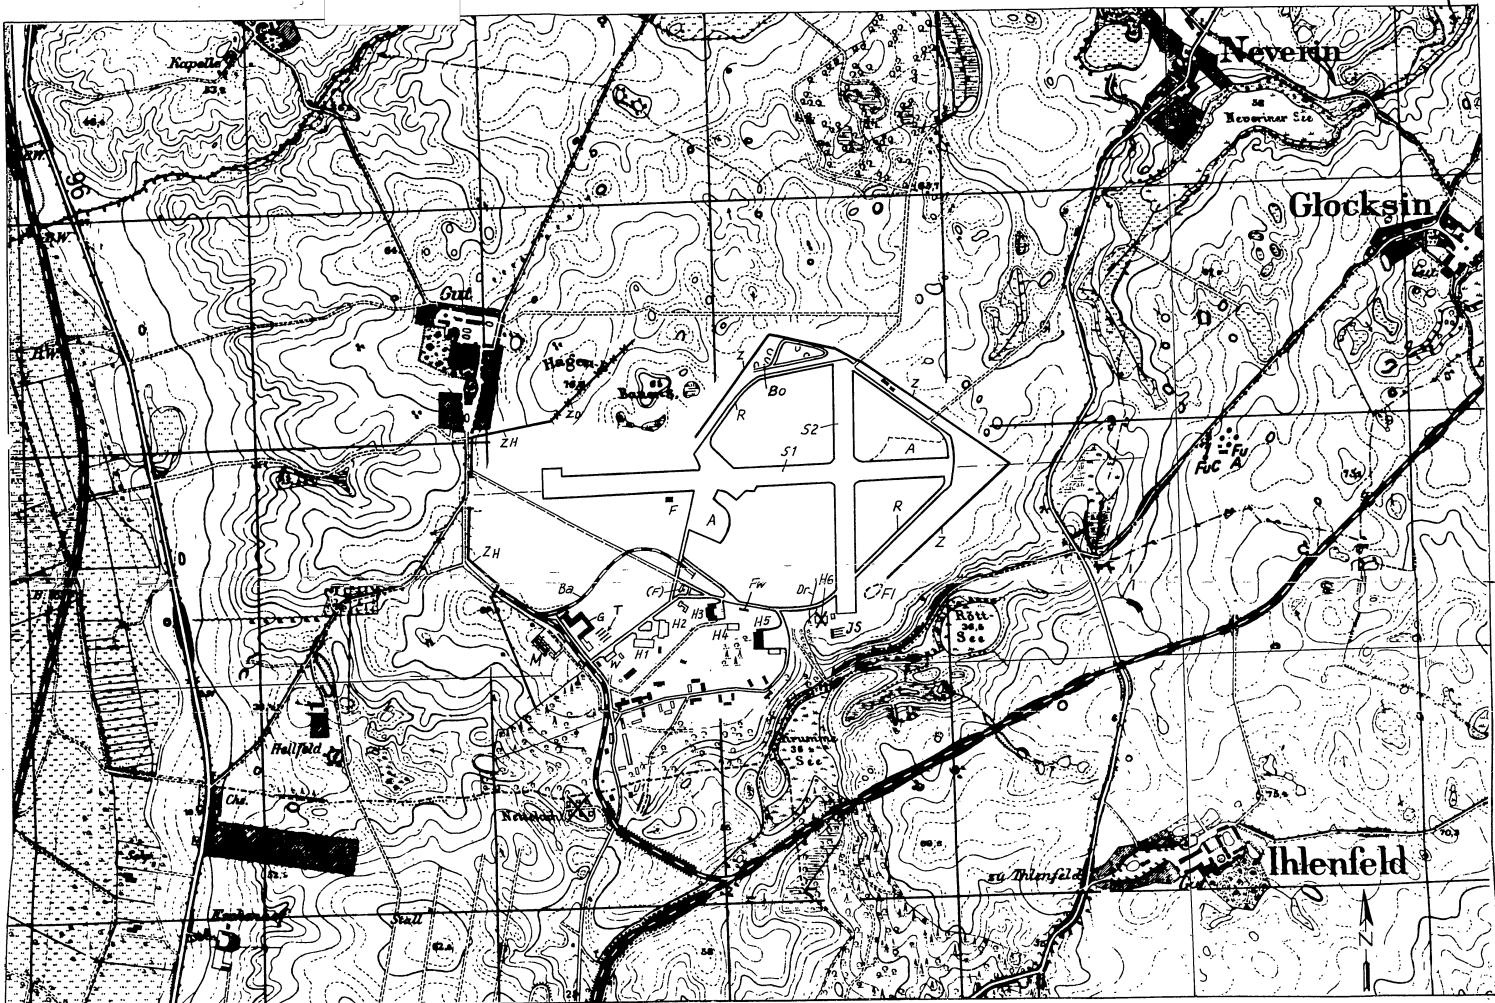
Flugplatz Neubrandenburg

Maßstab 1 : 12 500
